Manhole Inspection Summary

Manhole # S17AA2003MH

Insp Date: **4/3/07 9:29 AM**

Location Address: **1905 ROGERS AVE**

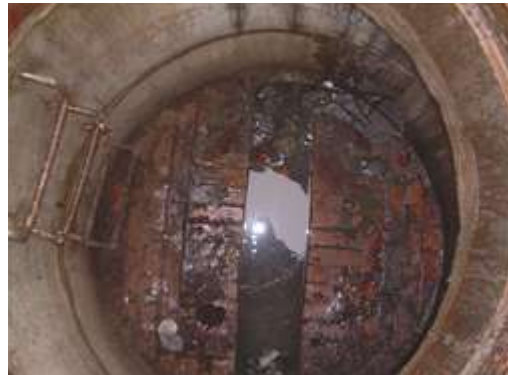
Top View

Evidence of surcharge - Bench debris.
Channel debris.

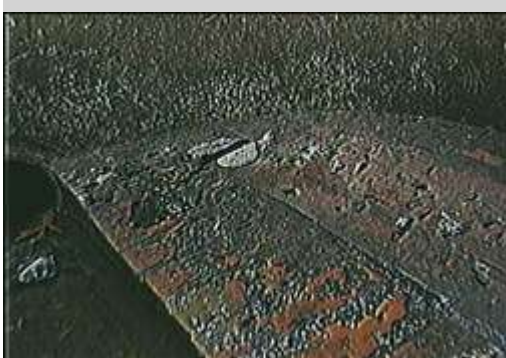
Evidence of surcharge - Bench debris.

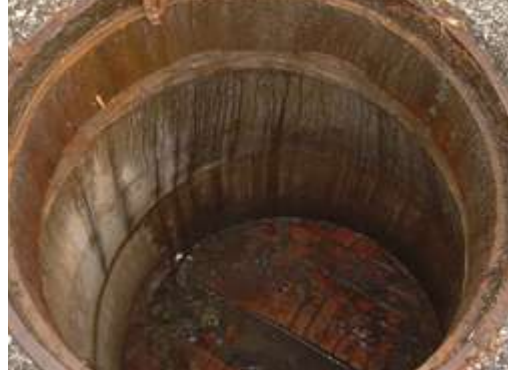
Defect

Frame leaks. Frame offset. Adjustment,
Corbel, and Barrel infiltration.

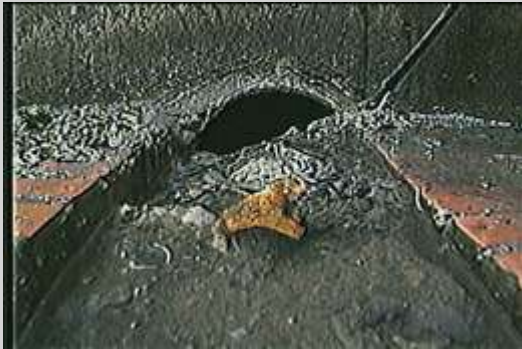
8 in. Circular Gravity Sewer Pipe Out @ 12 O'Clock

Deposits: ☐ None ☒ **Mud** ☐ Sludge ☒ **Debris** ☐ Grease

Silt Depth: **5** (in.) Deposits Extent: **Heavy**

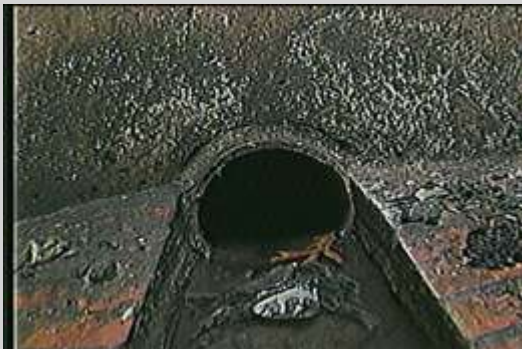
8 in. Circular Gravity Sewer Pipe In @ 6 O'Clock

Deposits: ☐ None ☒ **Mud** ☐ Sludge ☒ **Debris** ☐ Grease

Silt Depth: **2** (in.) Deposits Extent: **Medium**
